An Investigation on One of the Rainfall-Induced Landslides in Malaysia

Low Tian Huat

Mohd Asbi & Associates, Malaysia.

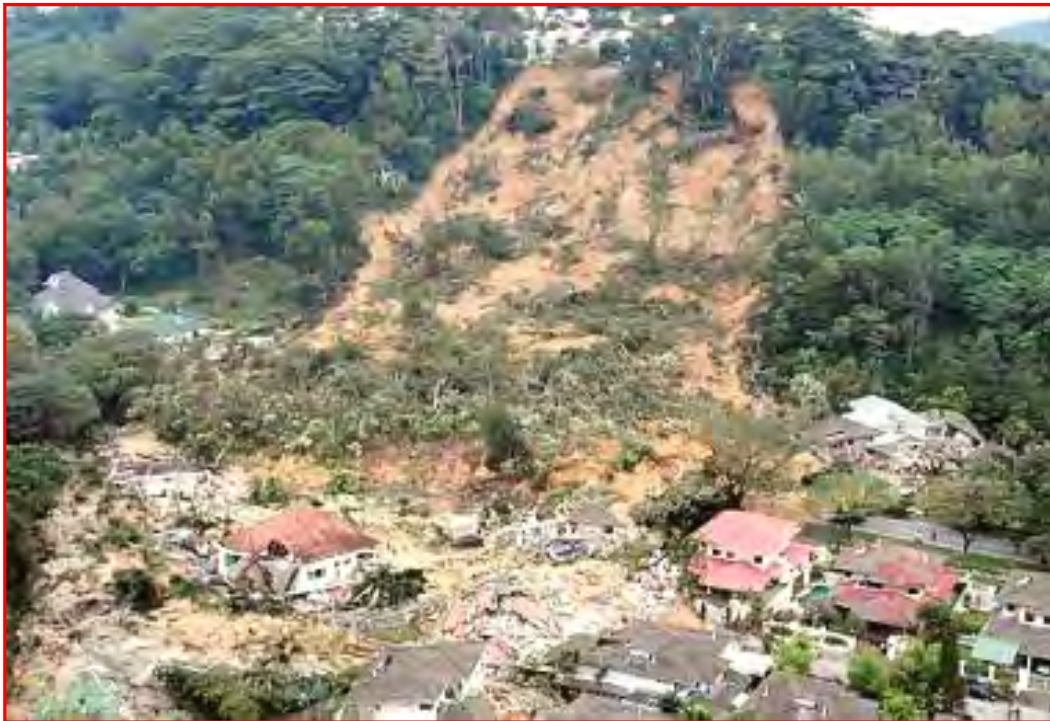
In the early morning of the 6th December 2008, a landslide occurred at Taman Bukit Mewah, Bukit Antarabangsa, Hulu Kelang, Selangor, Malaysia (Figure 1) (Slope Engineering Branch of the Public Works Department Malaysia, 2008). The landslide took place at approximately 3.30 a.m., measuring 109m in width at the crest, 120m in length, 15m in depth and the angle of the scarp at the crown was approximately 45° to 50°. It was estimated that 101,500 cubic meters of

The landslide debris completely blocked Jalan Bukit Antarabangsa, the only road access for some 5000 residents living in the area. Fourteen (14) bungalow houses were destroyed and five (5) fatalities and injury to fourteen (14) persons were reported.

Figure 1: Overall View of the Bukit Antarabangsa Landslide

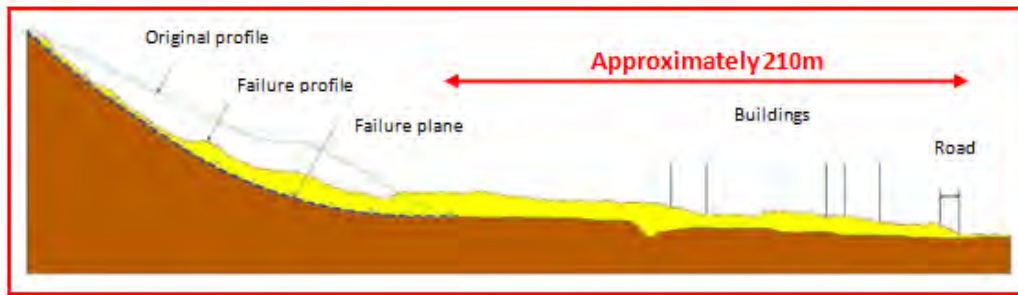
earth had translated and the maximum run out distance of the failure debris was measured at approximately 210m from the toe of the slope (see the cross-section in Figure 2).

Figure 2: Cross-section showing the Estimated Failure Plane and Failure Run-out Distance of 210 m

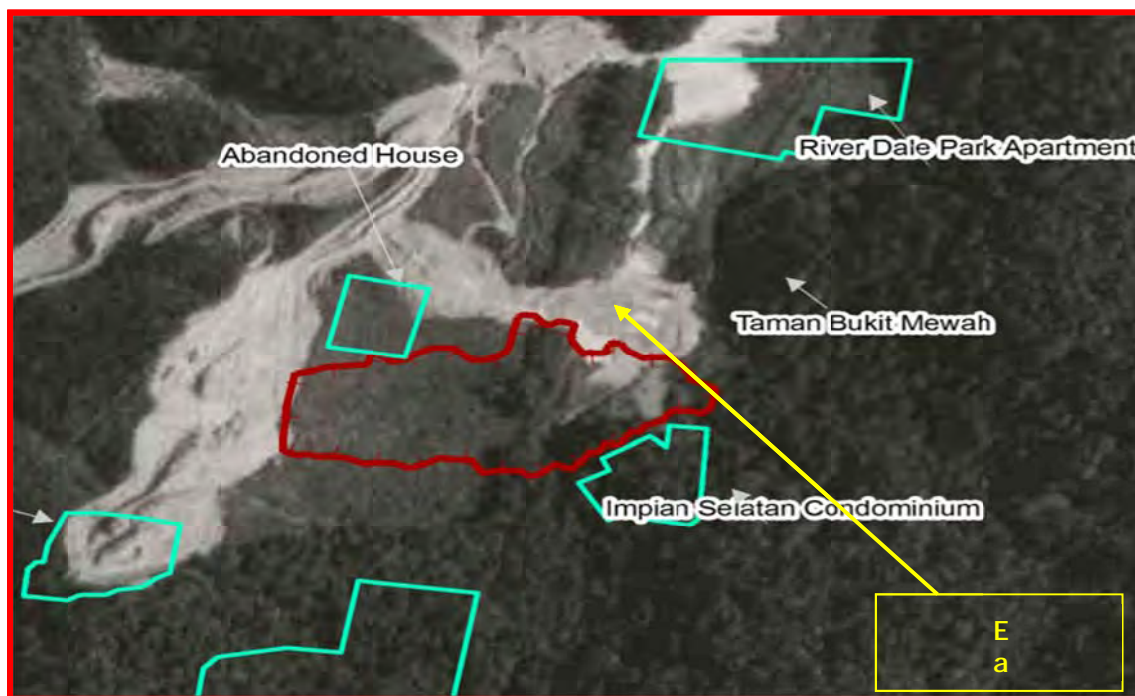
Aerial Photography: A series of aerial photographs from year 1966 to 2008 were provided and interpreted by the Department of Surveying and Mapping Malaysia (JUPEM) which revealed a history of the progressive development that had taken place at the landslide area and its vicinity (Figure 4). These aerial photographs were also interpreted by Minerals and Geoscience Department of Malaysia (JMG). Aerial photographs from 1966 show the existence of hill ridges, Sungai Seriang and its tributaries at the failure area (see Figure 5). By 1989, the ridge areas had undergone extensive development. The area that was once the river bank of Sungai Seriang formed part of Taman Bukit Mewah and the original river course was replaced by concrete drains and a large monsoon drain.

Figure 4: Aerial photograph (1975 by Department of Surveying and Mapping Malaysia) showing evidence of Earth Dumping

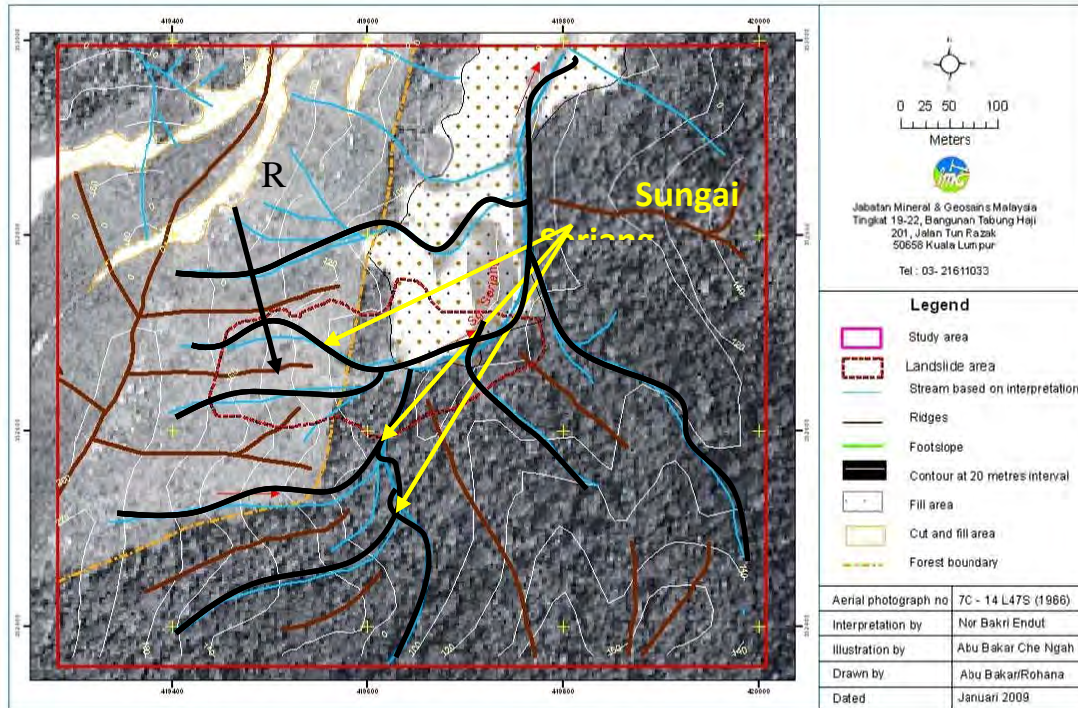
Figure 5: Aerial photograph (1966 by Minerals and Geoscience Department) shows the River, Sungai Seriang and its Tributaries

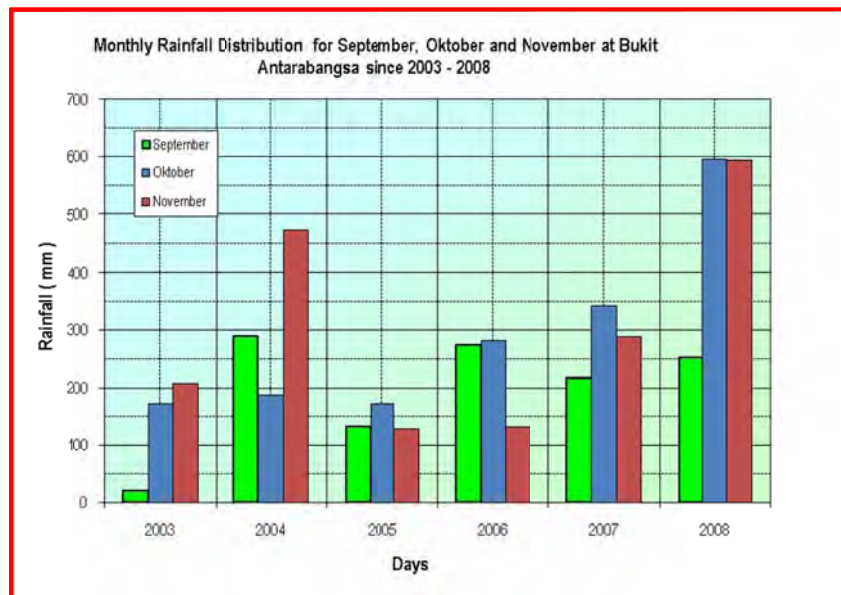
Rainfall Records: Rainfall records from 1st November 2008 to 7th December 2008 were collected from four (4) nearest meteorological stations to the landslide site. They ranged approximately 6km to 25km from the site. The rainfall station closest to the failure site was the Bukit Antarabangsa Station. However, the station was established in 2003; hence the only available monthly rainfall records were obtained for year 2003 to 2008 (Figure 6). It is clearly shown that the monthly rainfall for the month of October and November in 2008 recorded the highest rainfall since 2003. The monthly rainfalls for October and November 2008 are 594mm and 592mm respectively totaling 1186mm which is equivalent to 45% of the yearly average rainfall in Bukit Antarabangsa for the five (5) year period of 2003 to 2008.

Figure 6: Monthly rainfall records for the September, October and November 2008 at Bukit Antarabangsa Station

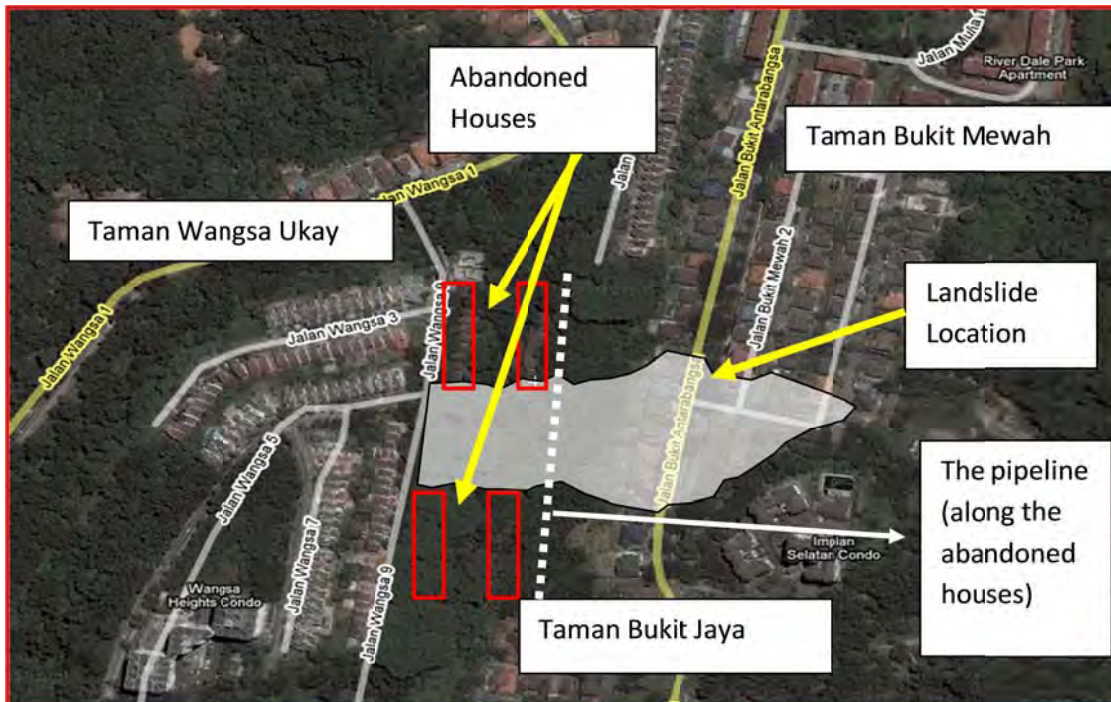
A team of geologists and geotechnical engineers carried out the geological and geomorphological mapping works. Among the observations included rows of abandoned houses very near to the failure area (see Figure 8). The failure also exposed a damaged water pipe of 215mm in diameter and sewerage pipes. These exposed pipes were located underneath the abandoned houses.

Figure 8: Failure area and location of the abandoned houses

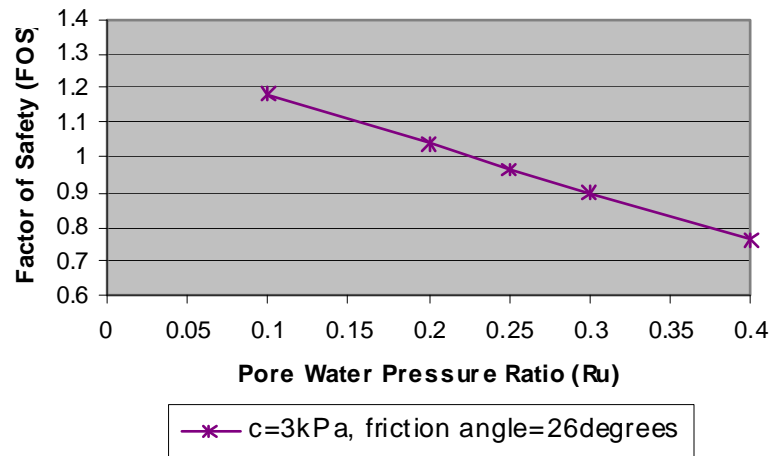
Various pore water pressure ratios (r_u) were applied in the analyses to obtain the Factor of Safety (FOS) at the toe of the slope (first slump). From the analysis, it can be concluded that the R_u value at failure is likely to range from 0.20 to 0.25 (see Figure 12). Hence, high pore water pressure is believed to have developed at the toe which triggered the initial deep-seated slide (the first slump). Subsequently, this over steepened the slopes above, causing the rest of the two slumps to slide down within minutes after the first slide.

Figure 12: Factor of Safety (FOS) versus Pore Water Pressure Ratios
