Inspection of the Pathological Manifestations on Janga Bridge

Located in the metropolitan region of Recife/PE, Janga Bridge is an important element of the highway infrastructure that connects the towns of Olinda and Paulista. Unlike the current situation, the bridge was built in 1974 when the municipality of Paulista had a population of approximately 70,000 inhabitants. Today, 42 years after its construction, the town has a population of over 300,000 inhabitants which entails it has to cater for a daily traffic flow of about 50,000 vehicles. Over the years, it can be verified that there were deficiencies in attending to the maintenance of the bridge which has led to its having noticeable signs of deterioration and consequently this makes its users feel insecure. Besides the lack of maintenance, Janga Bridge is located in an area classified as being of a Very Strong class of environmental aggression, in accordance with NBR 6118: 2014 – A Project of concrete structures - Procedure, implying that there is a high risk of the structure deteriorating. Given the above, this paper sets out to identify the pathologies present in the Special Work of Art, to determine their likely causative

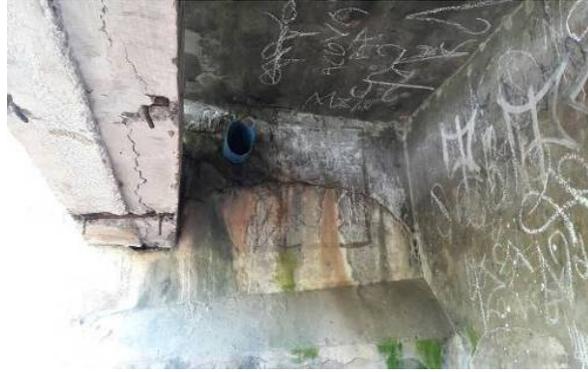
In our case study, fissures of various sizes and forms were found in various locations of the structure, these being a cause and consequence of other pathological manifestations. Figures 3 and 4 depict the situation found in the structure of the bridge (BERENGUER, RAMOS, CARNEIRO, MONTEIRO, NOGUEIRA SILVA & ALMEIDA, 2016).

Figure 3: Cracks in beam of the Bridge.

In the preliminary inspection, several fissures were found. These may have been caused for several reasons, among which the most likely are because they have been pitted by, among other acids, chlorides but another possible one is because of tidal waters that are in constant contact with it and their tidal variations. This takes place in the cycle of being made wet and dry, which is always present in the structure. As a result of leaching, due to the environment in which the bridge is located, cases of efflorescence may have occurred, which together with the fissures and concentration of free chlorides and the decrease in pH of the structure, have begun to corrode the rebars, thereby justifying the current situation in which the bridge is now in.

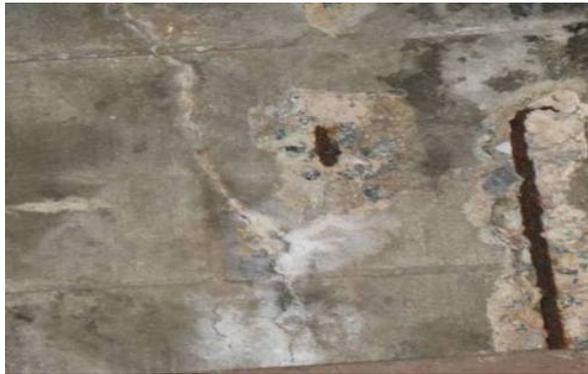
Figure 4: Fissures on the underside of the Bridge.

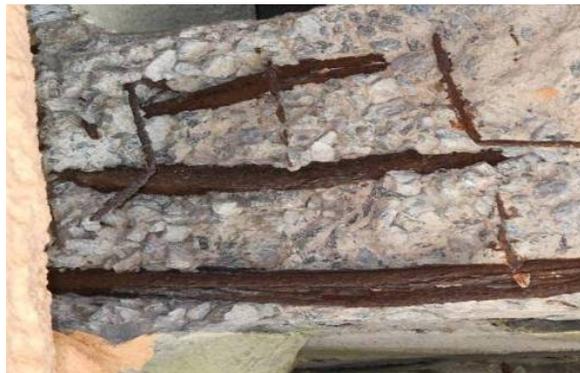
Sites were found throughout the length of the bridge which showed concrete had disaggregated, especially in the regions of the underside face of the beams, in different units. In some situations it was possible to unpick the aggregate of the structure manually, with practically no effort, thus demonstrating the advanced degree of disaggregation of the piece. Figure 5 shows an example of disaggregation verified on site.

Figure 5: Beam section with disaggregation of the piece.

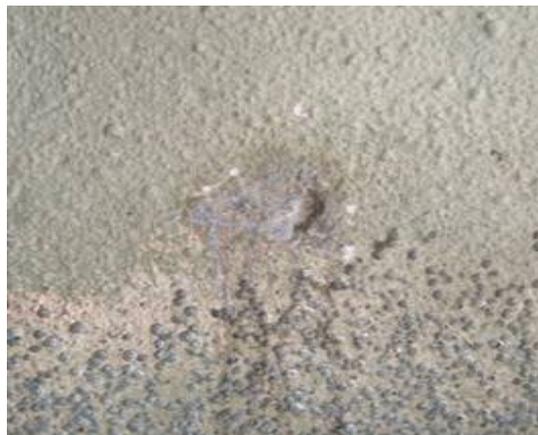
Figure 7: White color which serves as a means by which to evaluate the presence of free chlorides.

On using the silver nitrate spray test, the presence of free chloride ions was identified, thus explaining the occurrence of numerous points of corrosion on the rebars which are present in the whole structure of Janga Bridge;

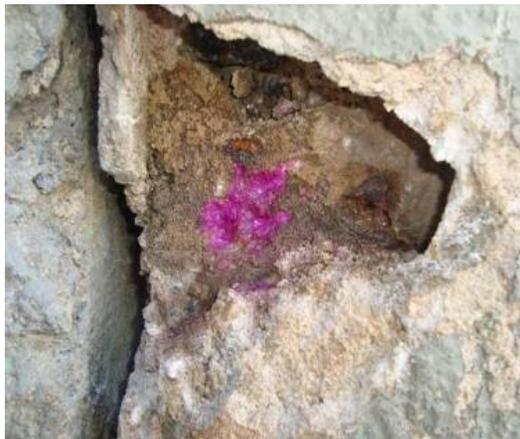
Figure 8: Phenolphthalein solution applied to the newly fractured areas of the structure of the bridge.

The test of assessing carbonation was positive for the place where it was performed, but this does not mean that this is not to be found in other places;

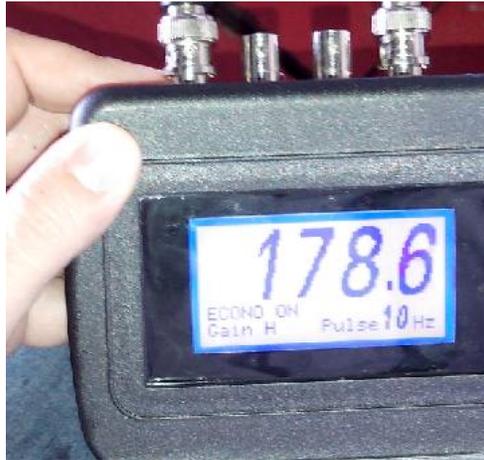
Figure 10: Result of the ultrasound test of the concrete structure of the bridge.

If one knows the space between the measurement and the time required to obtain it, by making calculations one can find the value of the propagation velocity of the ultrasonic wave, which reached 1,664.72 m/s. The quality of the concrete was considered poor because it achieved a result of less than 2,000 m/s, showing that it is not homogeneous, or this characteristic shows there are faults and fissures. Table 4 below lists the condition of the concrete with the velocity that was found of the propagation of the ultrasonic wave.

Despite the negative result, the test method has several variables that can influence the result, so it is recommended that more elaborate tests be carried out that certify the condition of the concrete.
