Failure Mode and Stability of a Landslide under Water Level Fluctuation

The failure mode and mechanism of a landslide are vital to landslide reinforcement design. The Tanjiawan landslide was used as an example to investigate into the failure mode and mechanism of the landslides in the Three Gorges Dam Reservoir, China. The structure of the landslide was analyzed through a lot of field investigations. Moreover, the failure mode of the landslide was studied with the data obtained by an integrated monitoring system, including GPS monitoring, extensometer and inclinometer monitoring. Finally, the stability of the landslide was evaluated with the rigid-body limit equilibrium method. It can be concluded that the landslide is a pushing landslide containing two main sub-landslides. The deformation of the Tanjiawan landslide develops from back to front relative to the Yangtze River. And the failure of this landslide is caused by the coupled actions of the rainfall and water fluctuation. The inclusions reported in this paper provide some useful suggest for the stability analysis and control structure design of landslides with a similar slope structure in the Three Gorges Reservoir region.

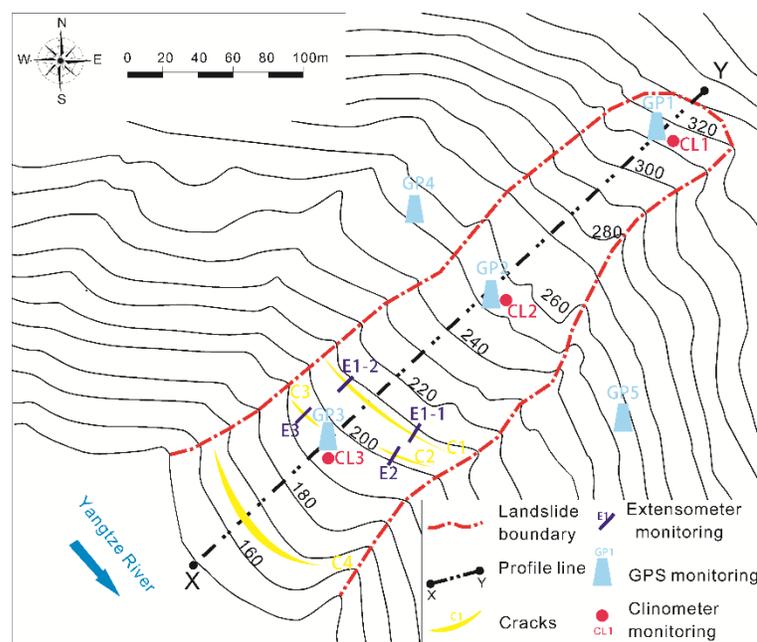
Tanjiawan landslide is situated at the left bank of Yangtze River, Dongxiangkou village, Maoping Town, Zigui County, Hubei Province. The sliding direction of the landslide is 215° . The landslide distributes between 145m and 350m in elevation, vertical height of the landslide is 205 m (Figure 1). The average angle of the slope is about 35° . The plane of the landslide is a rectangular shape, the length is 423 m, the width is between 60 m and 125 m, the average thickness of the sliding mass is about 25m. The landslide is about $100.4 \times 10^4 \text{ m}^3$ in volume.

Figure 1. Plane of the Tanjiawan landslide and location of monitoring works

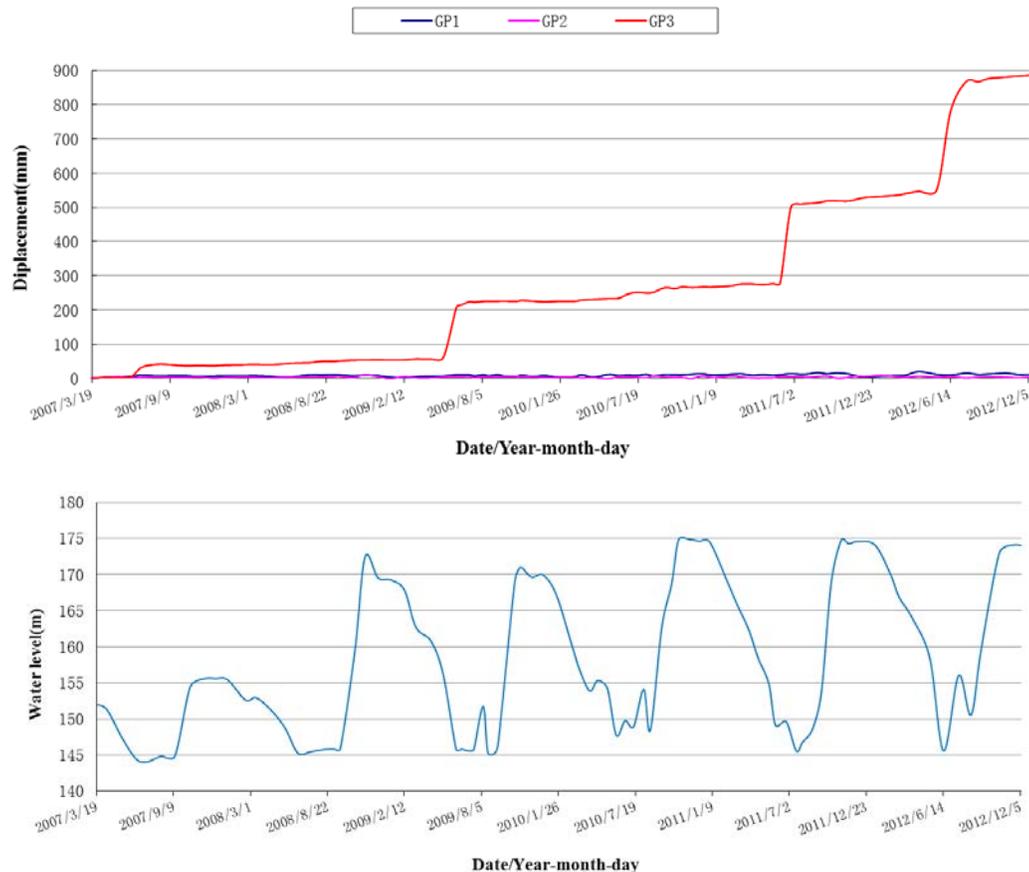
The data observed by GPS have shown a rather nonuniform movement of the whole landslide. In other words, the displacements in the front zones of the slope change a lot, but those in other zones change little. The total landslide movements were 12.0 mm at the head and 5.3 mm in the middle part, while the accumulated displacement in the front zone was up to 886.8 mm. Fig.2 illustrates the correlation between the landslide movements and water fluctuation. The top plot shows accumulated landslide movements measured at the three GPS benchmarks. The bottom plot illustrates reservoir

water level recorded in the capital of Badong County, about 5.3 km west of the landslide site. There were four significant rapid slides at the front of the landslide, which coincided with abruptly falling of water level. The average sliding rates of the front zones were 0.057 mm/d, 0.054 mm/d, 0.178 mm/d, and 0.144 mm/d during the falling of the reservoir level and were 1.193 mm/d, 5.320 mm/d, 9.617 mm/d, and 10.533 mm/d shortly after the descent of the water table.

Figure 2. Monitoring result of GPS and records of the reservoir level
