# Live Poles for Slope Stabilization in the Tropical Environment

## ABSTRACT

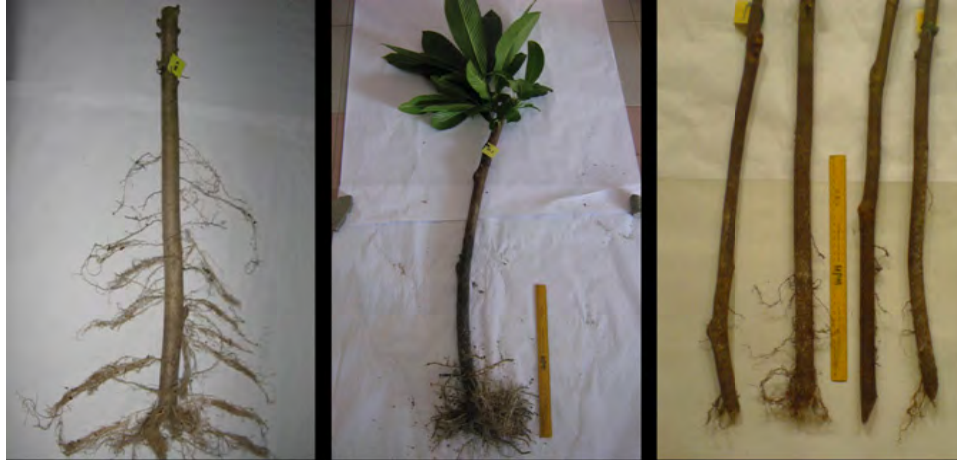
**Figure 4:** Selected species of first stage.

(a) *Hibiscus tiliaceus* (Ht) (b) *Dillenia indica* (Di) (c) *Dillenia suffruticosa* (Ds)

From the observations of the distribution/location and shape of the root growth (Figure 4) as *Pterocarpus indicus* had shown only end roots the other three species, namely, *Hibiscus tiliaceus* (*Ht*), *Dillenia indica* (*Di*) and *Dillenia suffruticosa* (*Ds*) were selected as the primary candidates to be used as live poles. The mechanical properties of these plant species were tested in the laboratory and these were replanted in selected natural soils to determine their ability to withstand field trials as described below.

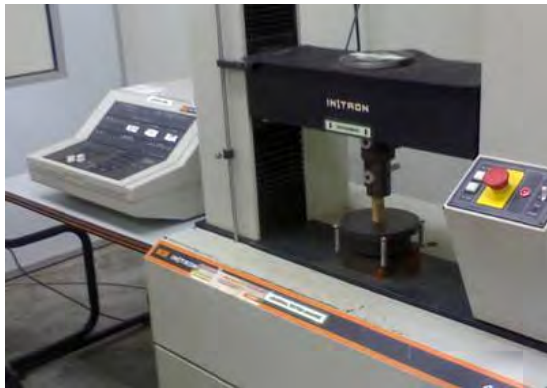
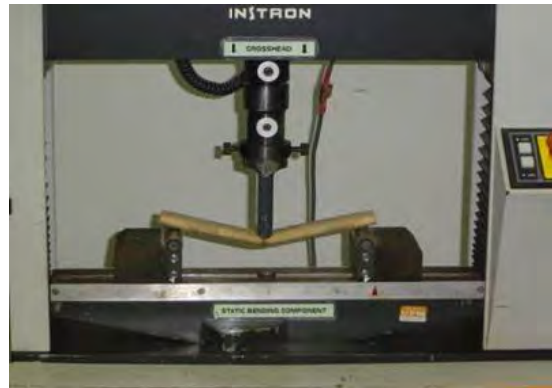
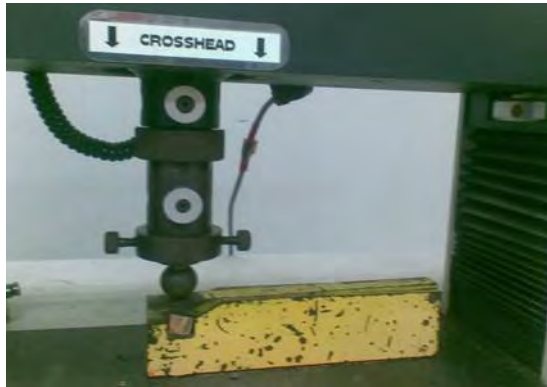
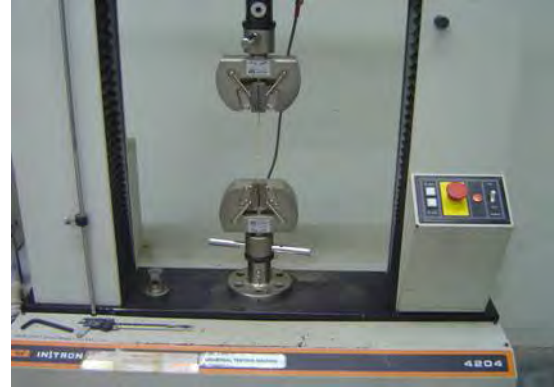
**Figure 5:** Methods of live pole mechanical testing

(a) Compression test of the stem

(b) Bending test of the stem

(c) Shear test of the stem

(d) Tension test of the root

second series investigated the tensile strength of the roots based on the ASTM D1037-99. These laboratory tests were conducted by using the Universal Testing Machine (Instron, Model 4204, United Kingdom). Figure 5 shows the samples under testing conditions.

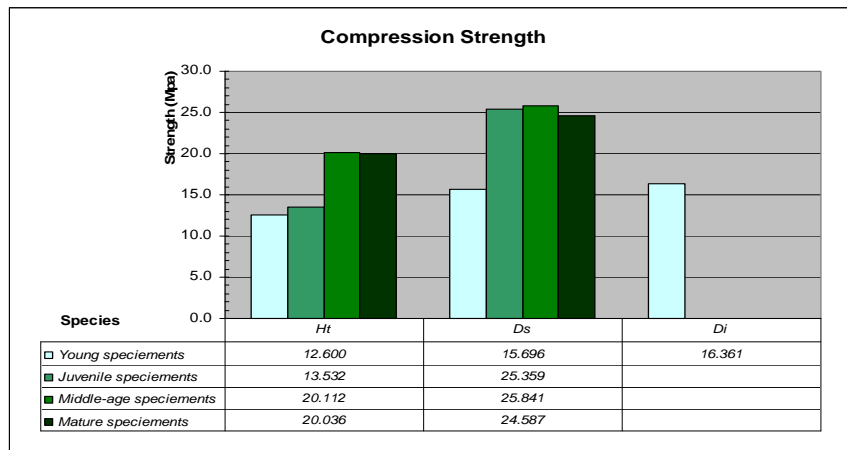
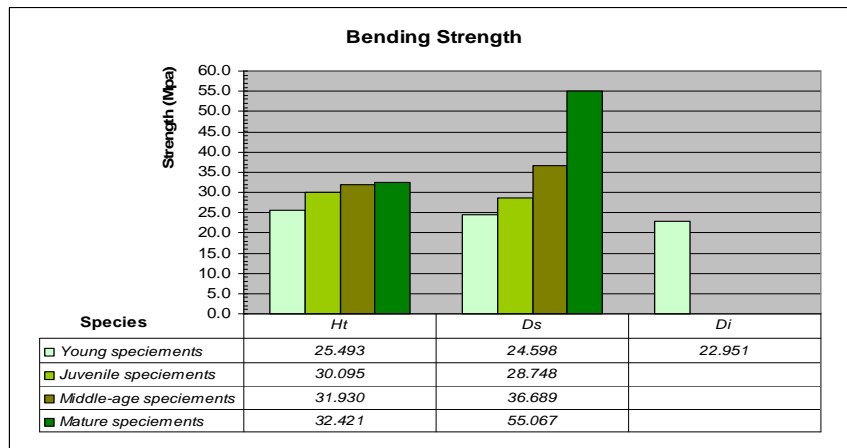
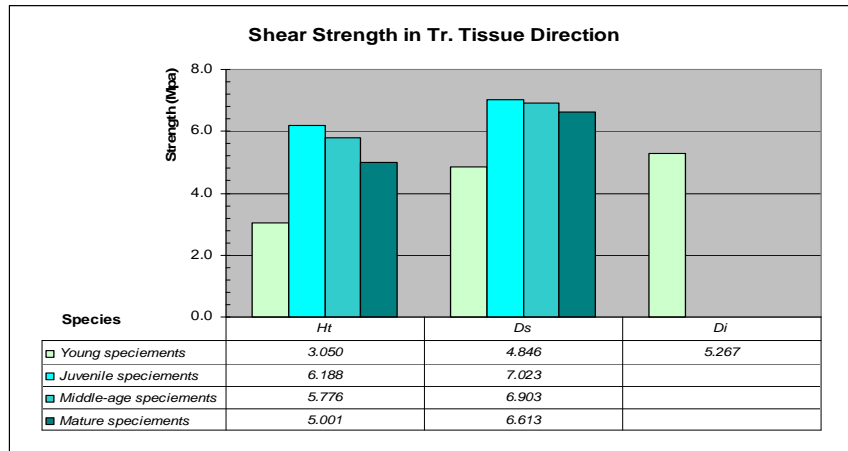
Figure 6: Comparing mechanical properties of selected live pole

(a) Compression strength

(b) Bending strength

(c) Shear strength

The results of the strength tests on stems are summarized in Figures 6. As is obvious from Figure 6 *Ds* has on the whole the highest average mechanical properties as compared to *Ht* and *Di* (38% to 40% more average compression strength than *Ht* and *Di* respectively, 20% and 60% greater average bending strength than *Ht* and *Di* respectively and is more than 27% stronger than *Ht* in its average shear strength) and only in its shear strength is *Di* about less than 10% and 40% stronger than *Ds* and *Ht* respectively.

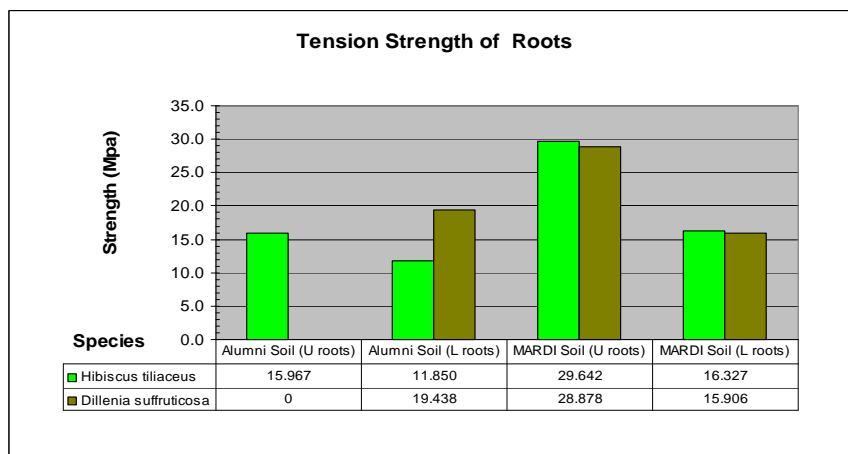
Figure 7: Comparison of the tensile strength of the roots of the selected live pole species

As seen in Figure 7, the average tensile strength of both the *Ds* and *Ht* roots from the Jln. MARDI soils is almost the same. However, the *Ds* roots are seen to be nearly 40% stronger than the *Ht* roots in the Jln. Alumni soil. Moreover, it is observed that the average tensile strength of the upper roots of both plants is about 35% more than the average strength of their lower roots.

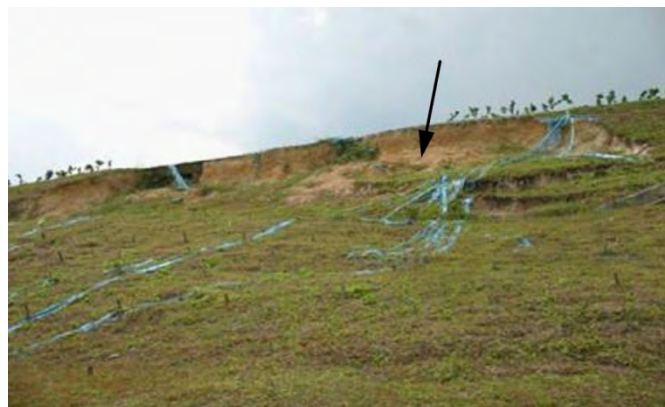
Figure 8: 1<sup>st</sup> trial site as in July 2007

(a) General view

(b) Surveying section

This slope had a general angle of inclination of about  $29^\circ$ , with shallow failures (0.95 - 1.5 m deep) at several locations. Most of the failures were rotational failures, but a translational failure was also evident in this slope. The slopes were quite wet, with softer sandy soils of shale origin (weathering grade VI). Figure 8 shows a general view and surveying section of this trial site as in July 2007.

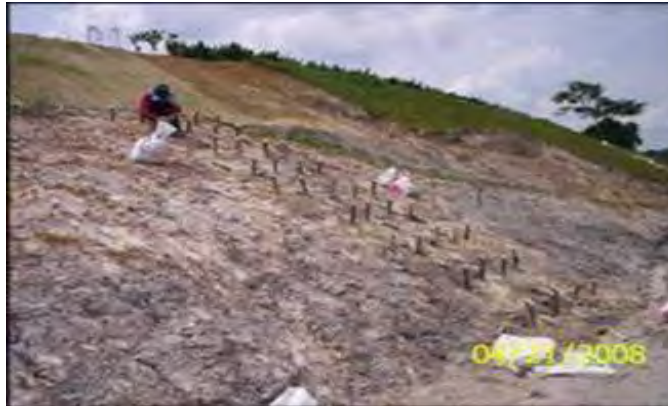
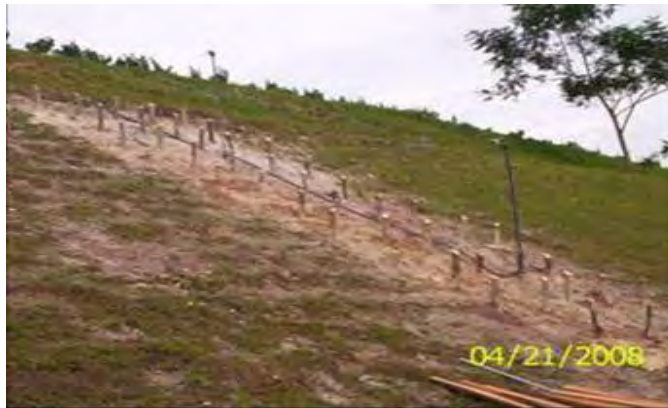
**Figure 10:** 1<sup>st</sup> trial site as in April 2008

(a) Trial strip 1

(b) Trial strip 2

Live poles of *Ht* and *Ds* were used on this slope. Two trial strips were installed with a grid of live poles at 0.5 by 0.75 meter staggered centers across and down the slope with alternative rows of *Ht* and *Ds* (Figure 9). They were planted as stem cuttings to a depth of 1.5 m below the ground surface. The first strip as shown in Figure 10(a) was a re-graded section of an already failed slope shown Figure 8(a). The next trial strip was about 50 m away to the south along the slope as shown in Figure 10(b).

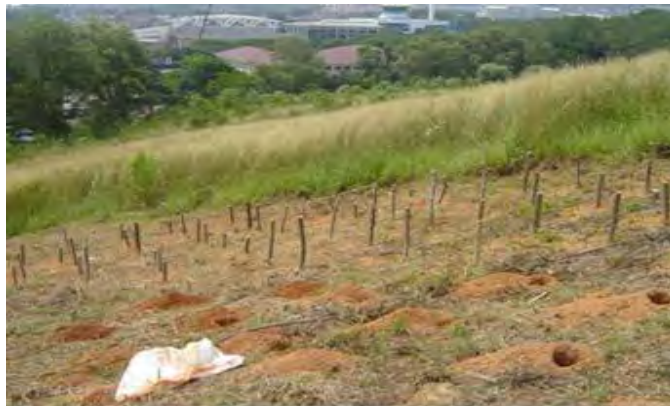
**Figure 12:** 2<sup>nd</sup> trial site during planting on May 2008

This slope had an angle of inclination of about  $28^{\circ}$  and it seemed stable. It was apparently drier than the first slope with a harder (gravelly) soil (i.e. of weathering grade V) of sandstone origin. Again *Hibiscus tiliaceus* (*Ht*) and *Dillenia suffruticosa* (*Ds*) were selected for the live poles in this site, as they were proven to be more versatile and adaptable. An area of about 9.0 m by 10.5 m along and down the slope was installed with a grid of live poles at 1.0 by 0.75 m staggered centers across and down the slope (Figure 11). The stem cuttings were planted in alternate rows to a depth of 0.75 to 1.0 m respectively below the ground surface (Figure 12).

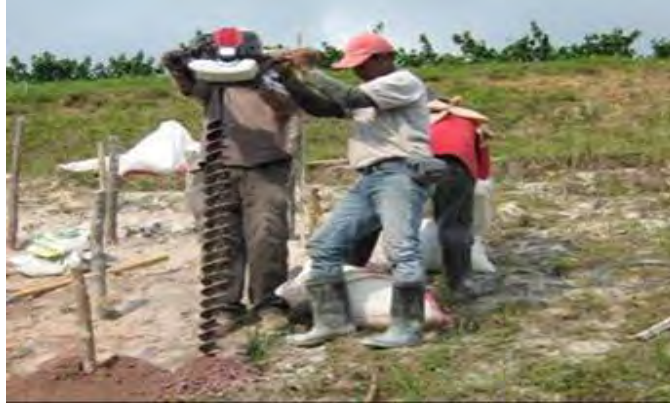
**Figure 13:** A two-man powered auger team preparing the pre-formed hole

The live poles were removed from a forest near the campus and installed in batch after holes (of about 100 mm in diameter) had been pre-bored into the ground for their installation using a two-man powered auger as shown in Figure 13.

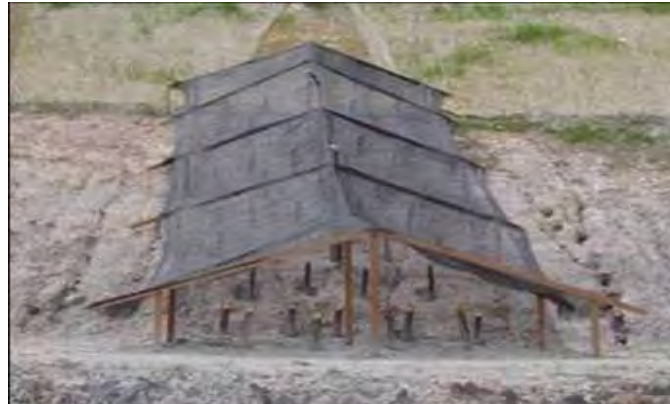
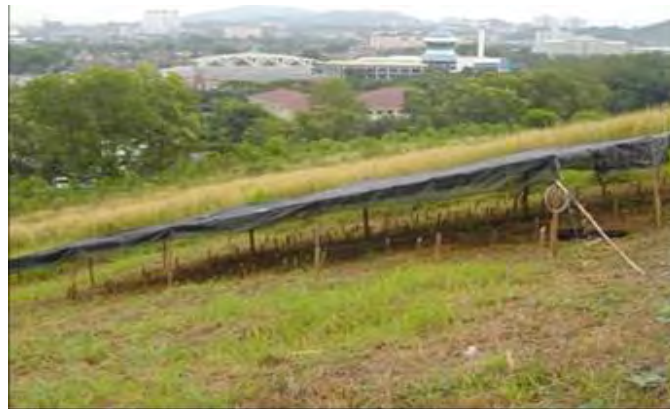
**Figure 14:** Completed installation of live poles  
(with irrigation system and temporary shades)

(a) 1<sup>st</sup> trial site (strip 1)

(b) 2<sup>nd</sup> trial site

In addition, an irrigation system and a temporary shading cover of a plastic net were installed at each of the trial sites (Figures 14).

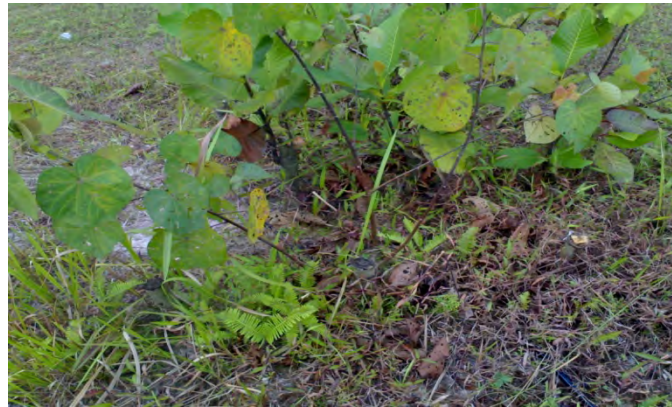
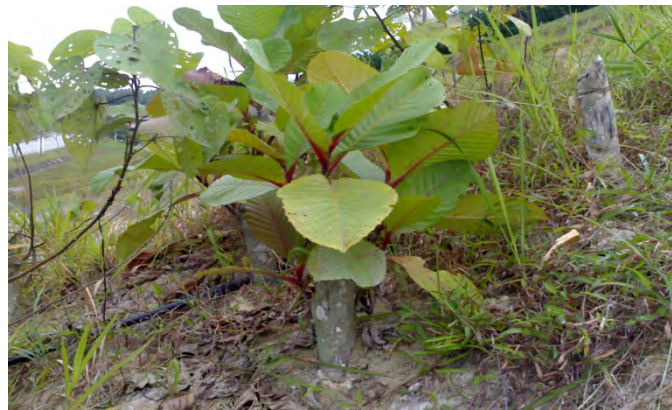
**(b)** Trial strip 2**Figure 15:** Live poles at the 1<sup>st</sup> trial site 10 months after planting

The observed growth/survival rates of the live poles are given in Table 5. Figure 15 and 16 show the progress of the live poles at the two trial sites after 10 months. The survival rate at the 1<sup>st</sup> trail at Jalan MARDI site seems low, with little difference between the North and South trial strips. However, the rate at the 2<sup>nd</sup> trail site at Jalan Alumni was more satisfactory.

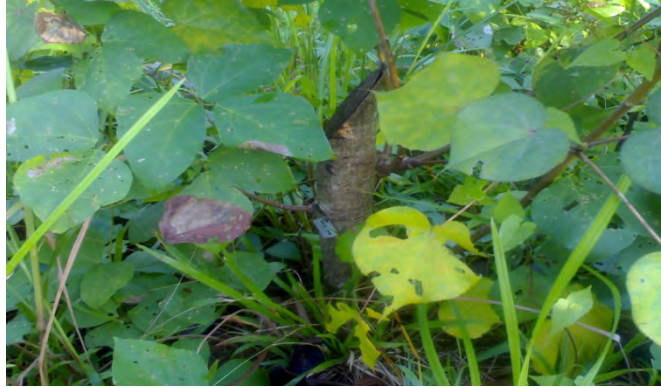
**Figure 16:** A *Ht* Live pole at the 2<sup>nd</sup> trial site 10 months after planting.

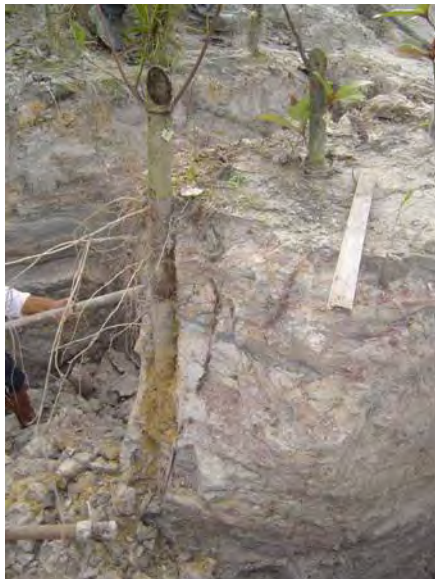
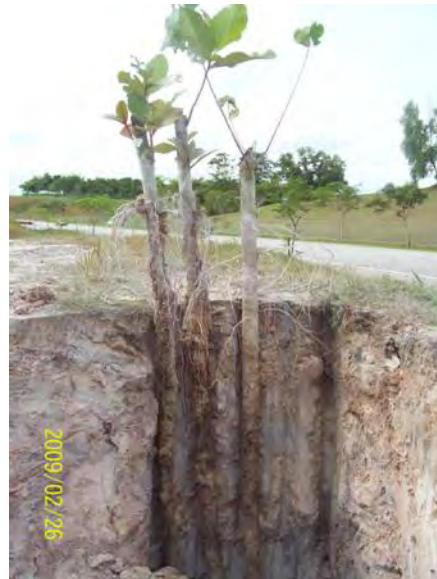
**Figure 17:** Exhumation of live poles at the 1<sup>st</sup> trial site at Jalan MARDI

**(a)** An *Ht* pole during excavation

**(b)** Live poles after removing

At the end of the monitoring period 2 *Ht* and 2 *Ds* live poles were exhumed from the 1<sup>st</sup> trial site at Jalan MARDI in order to study the specification and properties of the live poles in a field condition (Figure 17). The geometry and topology of the roots and the live pole strength parameters were determined.

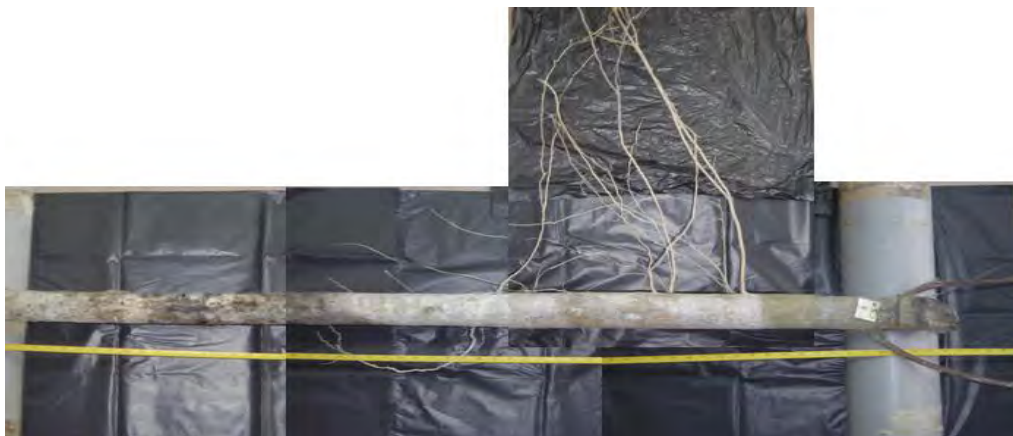
**Figure 18:** An exhumed *Ht* live pole

A visual comparative study of *Ht* and *Ds* live poles (Figures 18 and 19) showed that (on average) 1625mm of the total 1850mm length of the *Ht* poles were under the ground whereas for the *DS* poles it was 1635 mm (on average) of about a total length of 1950 mm.

The roots of *Ht* had grown only on 25% of the length under the ground but for the *Ds* roots could be seen along 31% of its embedded length. On the other hand, roots of *Ht* seemed longer (length: 230mm to 1230mm) and thicker (diameters: 0.5mm to 5.7 mm) than the roots of *Ds* (length: 350mm to 1060mm and diameters: 0.5mm to 2.5mm).

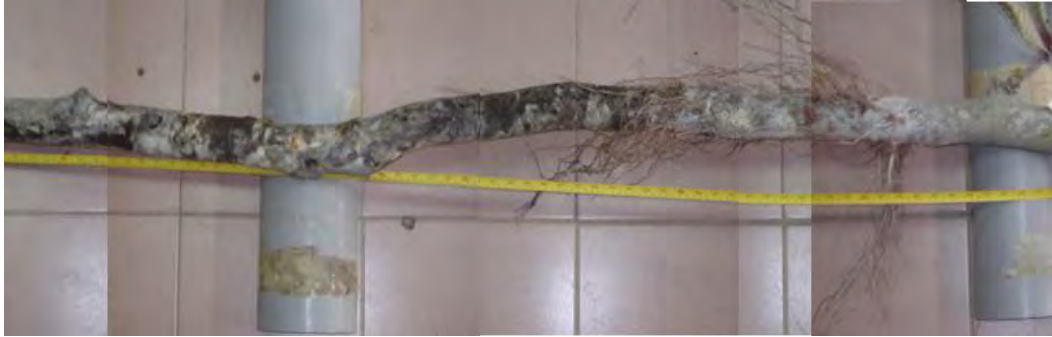
**Figure 19:** An exhumed *Ds* live pole

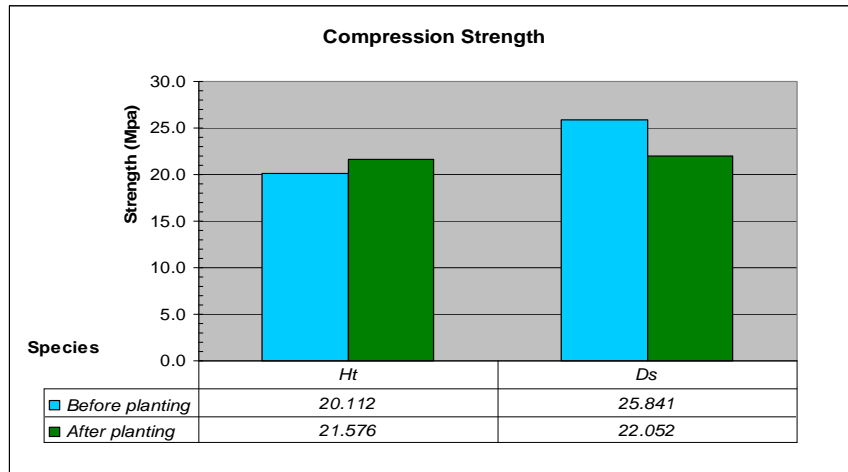
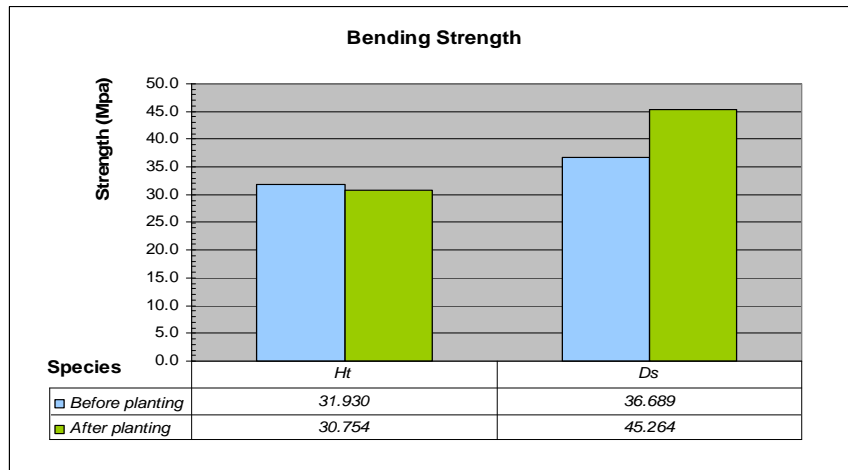
Figure 20: Comparison of the mechanical properties of the live pole stems after planting

(a) Compression strength

(b) Bending strength

(c) Shear strength

The strength of the live pole stems before and after planting are compared in Figure 20. It is obvious that the difference between the mechanical properties of *Ht* poles at about  $\pm 1\%$  to 8% is not very considerable while for the *Ds* poles the compression and shear strengths decreased by 15% and the bending strength increased by 25% after planting.

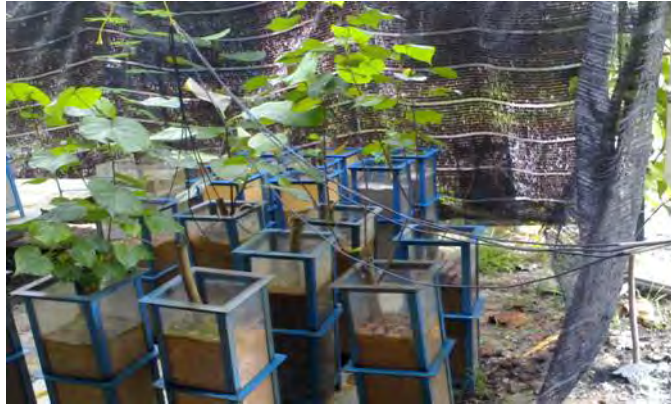
**Figure 21:** Samples for soil suction testing beside the shade-house

The testing commenced just after the samples were planted. Four micro-tensiometers 100 HPa capacities connected to a data logger system were install at depths of 200 mm or 400 mm in each container (Figure 21 and 22).

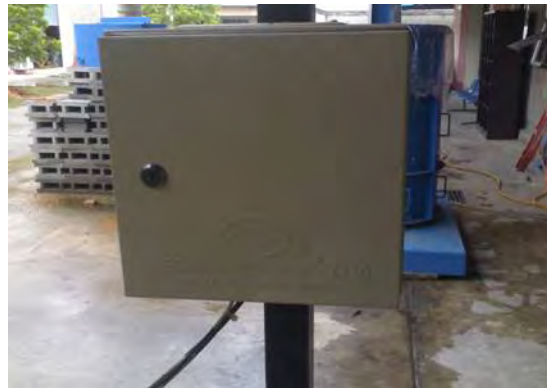
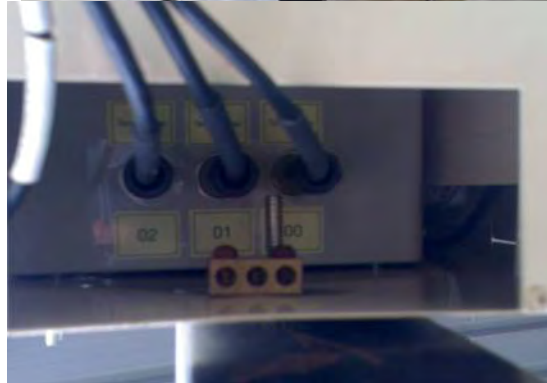
**Figure 22:** Method of live pole testing

**(a)** Date logger box

**(b)** Connection of tensiometers to logger
