An Investigation on One of the Rainfall-Induced Landslides in Malaysia

Low Tian Huat

Mohd Asbi & Associates, Malaysia.

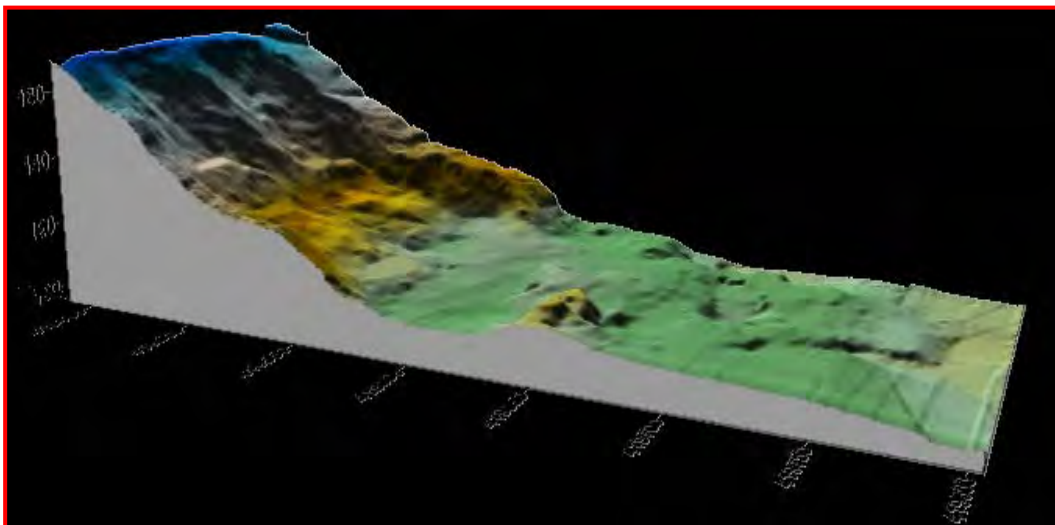
Figure 7: 3D Terrain Model produced from Terrestrial LiDAR Survey (TLS)

Detailed topographical survey is important in determining the terrain model of the failed area. Terrestrial LiDAR survey (TLS) was carried out to map the failure zone. Figure 7 shows a 3D terrain model produced from TLS.

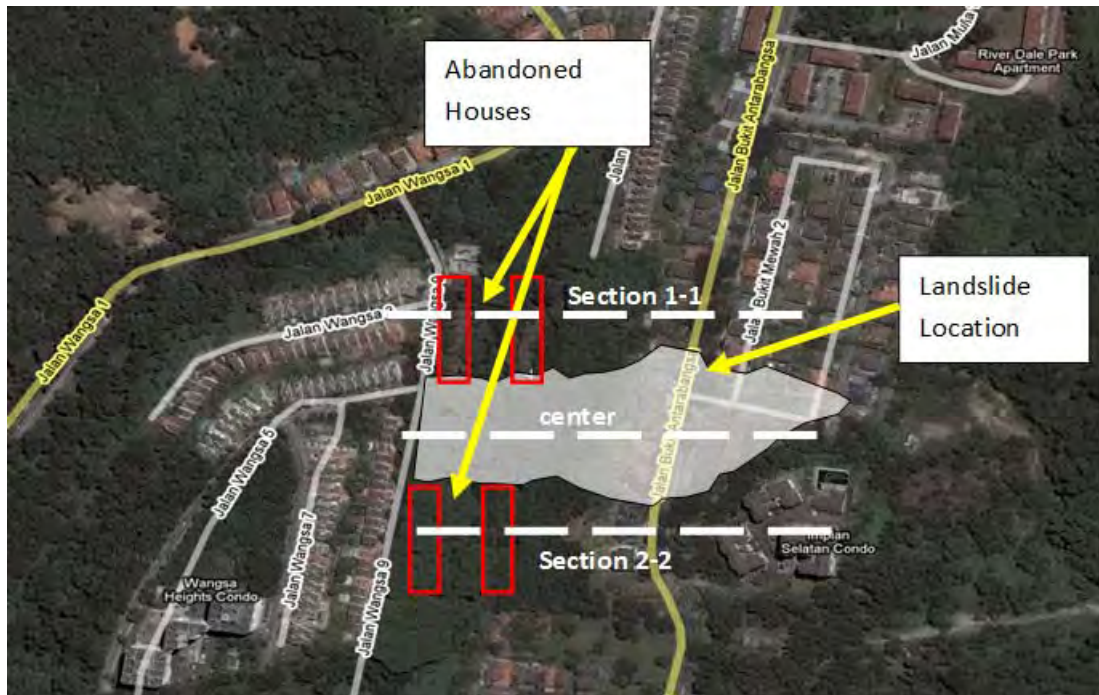
Figure 11: Location of the Cross-Sections in the Analyses

Three (3) cross-sections were simulated in the stability analysis using SLOPE/W (2007) computer program adopting Morgenstern-Price's method, satisfying both the force and moment requirements. The three (3) cross-sections studied are within the landslide area, i.e., center of the landslide, Sections 1-1 and 2-2 (right and left side of the failure-see Figure 11).
