Inspection of the Pathological Manifestations on Janga Bridge

Located in the metropolitan region of Recife/PE, Janga Bridge is an important element of the highway infrastructure that connects the towns of Olinda and Paulista. Unlike the current situation, the bridge was built in 1974 when the municipality of Paulista had a population of approximately 70,000 inhabitants. Today, 42 years after its construction, the town has a population of over 300,000 inhabitants which entails it has to cater for a daily traffic flow of about 50,000 vehicles. Over the years, it can be verified that there were deficiencies in attending to the maintenance of the bridge which has led to its having noticeable signs of deterioration and consequently this makes its users feel insecure. Besides the lack of maintenance, Janga Bridge is located in an area classified as being of a Very Strong class of environmental aggression, in accordance with NBR 6118: 2014 – A Project of concrete structures - Procedure, implying that there is a high risk of the structure deteriorating. Given the above, this paper sets out to identify the pathologies present in the Special Work of Art, to determine their likely causative

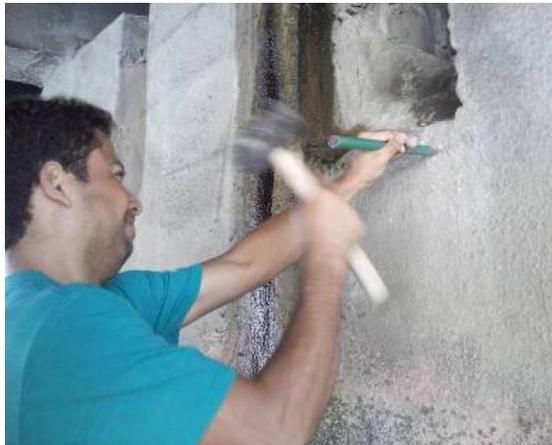
The evaluating free chlorides tests by the silver nitrate spray method, was undertaken on Janga Bridge (bank with reference to upstream of the River Paratibe) on the pillar wall. Part of the concrete of the support of the bridge was fractured and the silver nitrate solution was sprayed in two separate places; the solution was proportionally scaled in a 200 ml container which was wrapped with a paper to prevent light entering it, all in accordance with the standard (UNI, 1978). A photochemical reaction was used to find results and both were positive for the presence of free chloride ions in the structure, represented by a white color. There was no difficulty either in conducting the test, or as to viewing the results, thereby demonstrating how convenient and quick it is to detect the problem. The cost also proved to be quite affordable regarding the tests performed in the laboratory, thereby confirming the reason why its use has become so recurrent. Figures 6 and 7, respectively, demonstrate the process engaged on for the test, with the breaking of the surface of the concrete, spraying the solution and evaluating the coloration that indicates the result coloration, respectively.

Figures 6: Breaking the surface of the concrete

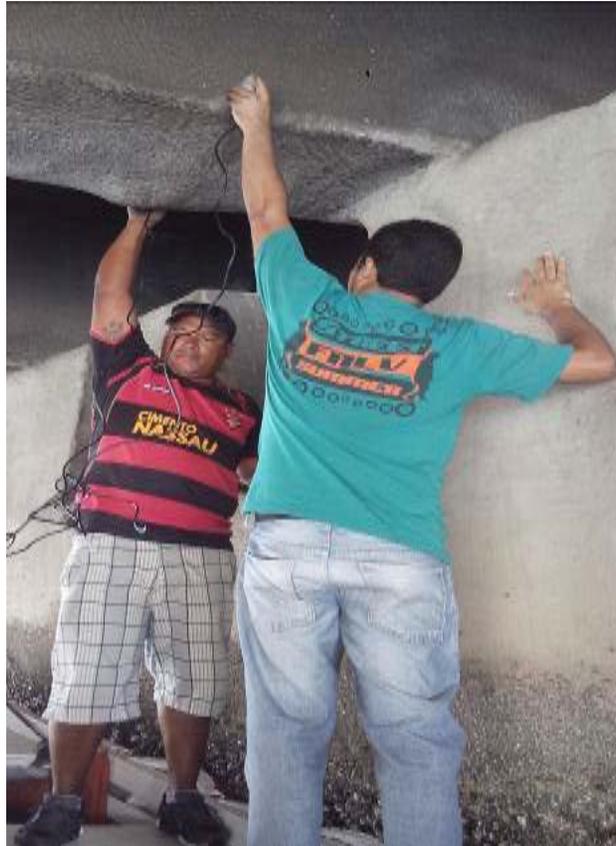
According to ABNT/NBR 8802 (2013) the concrete was tested by the semi-direct transmission method, with a length of 29.7 cm, on one of the supports located on the banks upstream of the Capibaribe river. Prior to measuring the propagation velocity of the ultrasonic wave, the apparatus had to be calibrated. Moreover, the concrete surface of the structure needed to undergo adjustment so that the value found would be as consistent as possible, thus minimizing errors. After the initial process of calibrating the apparatus, measurements began to be taken, as shown in Figure 9. The apparatus reached the result 178.6, with a pulse of ten Hz, as shown in Figure 10.

Figure 9: Start of the ultrasound test of the concrete structure of the bridge.

If one knows the space between the measurement and the time required to obtain it, by making calculations one can find the value of the propagation velocity of the ultrasonic wave, which reached 1,664.72 m/s. The quality of the concrete was considered poor because it achieved a result of less than 2,000 m/s, showing that it is not homogeneous, or this characteristic shows there are faults and fissures. Table 4 below lists the condition of the concrete with the velocity that was found of the propagation of the ultrasonic wave.

Despite the negative result, the test method has several variables that can influence the result, so it is recommended that more elaborate tests be carried out that certify the condition of the concrete.
